RE: Site Inspection, Umetco Minerals Corporation, Calliham Mine, M/037/023, San Juan County, Utah

Date of Inspection: September 7, 2000

Purpose of Inspection: To examine recent reclamation work at the site

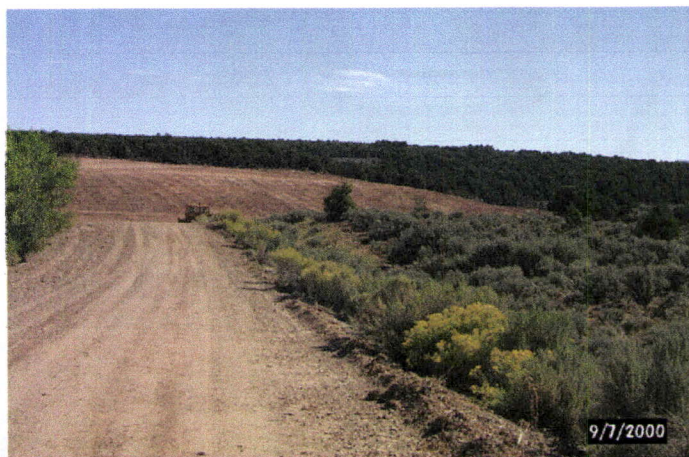
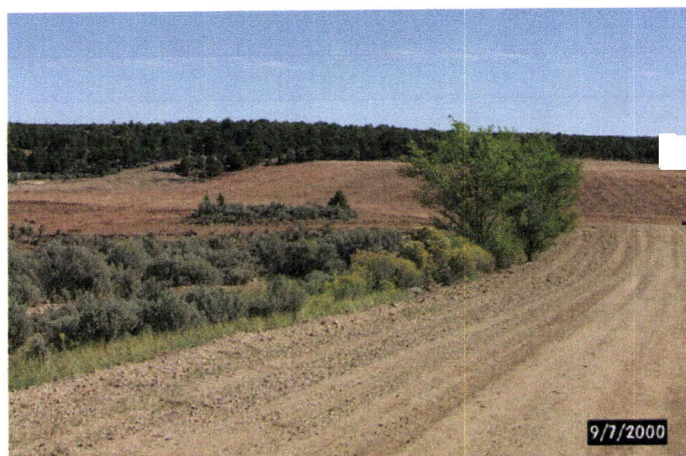
CONSOLIDATED & REGRADED WASTE DUMPS

The inspection began with a distant view of the regraded mine dumps from the access road to the site. Photographs of the site from this vantage point show the access road into the site with a piece of equipment at the end of the road and the regraded dumps in the background.

The low grade waste piles and ore pads have been regraded into one area rather than creating several regraded piles. Although this was not described in the original reclamation plan, it was beneficial to combine the waste into one area to minimize the disturbance. In addition, topsoil from beneath the low grade waste pile and ore pads was then salvaged for use in covering the consolidated waste pile. Frank believed there was at least six inches of soil cover over the regraded waste pile. The areas covered with soil have not yet been seeded.

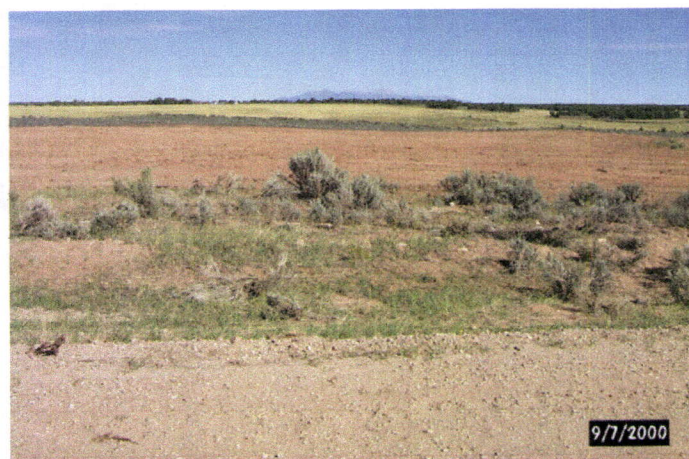
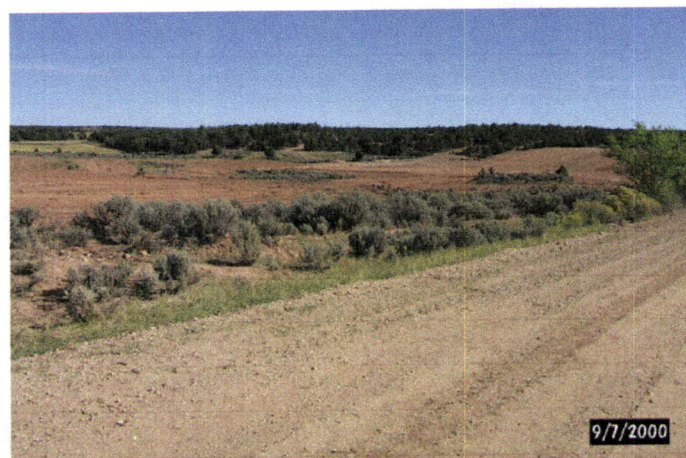
REGRADED POND AREA

The next area examined was the site where the ponds had been located. This area has been regraded and appears as rolling terrain with a slight depression. Photographs of the regraded pond area were taken looking toward the north with the LaSal mountains in the background. The regraded ponds will next be disced, drill seeded and then imprinted by Umetco sometime this fall, 2000.

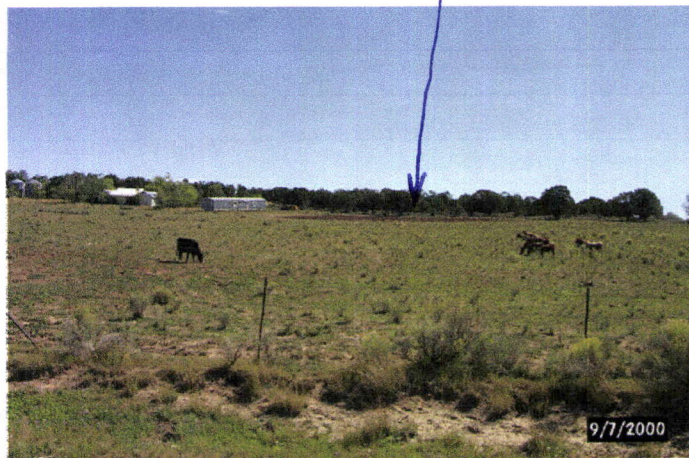
CALLIHAN #3 VENT HOLE

The next feature examined was the Calliham #3 vent hole. The reclaimed vent hole now appears as a roughened area in a field with cows next to a trailer house. A piece of the metal yellow duct work was on the ground near the house for use by the landowner.

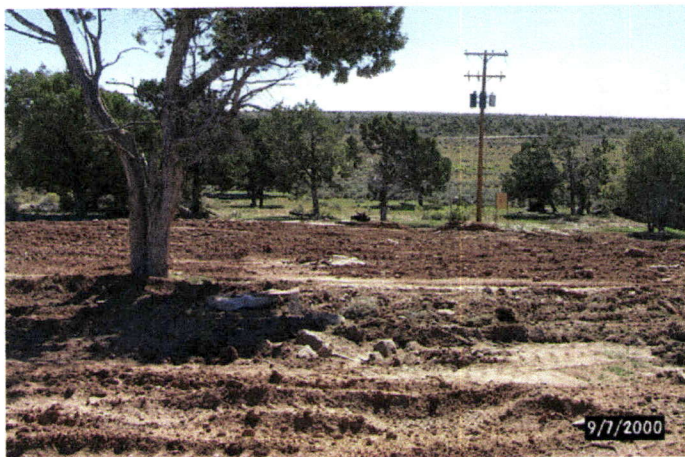
SKIDMORE #2 VENT HOLE

The next feature examined was the Skidmore #2 vent hole. A photograph of this vent hole shows the regraded area with trees in the foreground and a section of vent duct in background. The landowner wants this ventilation duct for use as a culvert or some other purpose. Near this vent hole site was the compressor building. A concrete pad with an assortment of iron were all that remained of the compressor building. The iron materials are to be removed, or given to the owner. The concrete slabs are also to remain at the request of the landowner.

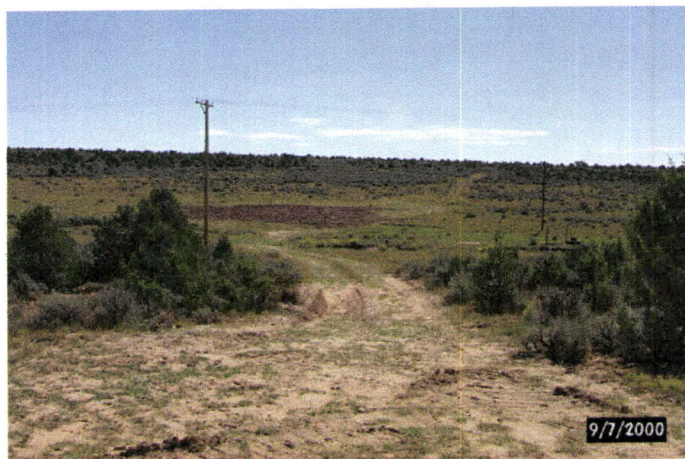
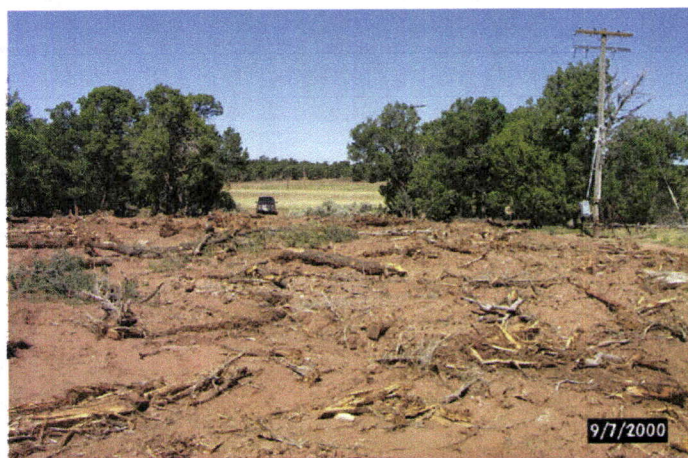
CALLIHAN #2 VENT HOLE

The next feature examined was the Calliham #2 vent hole. This vent hole was thought to be cased, but upon doing the reclamation it was discovered the vent hole was not cased. The section of ventilation duct work was pulled out of the hole and the hole was backfilled to the surface. The backfill material was allowed to settle and then backfilled again. A concrete cap was poured over the backfill and the cap was then covered with several feet of soil to match the surface elevation. Photographs of this site show a regraded area covered with a lot of brush debris.

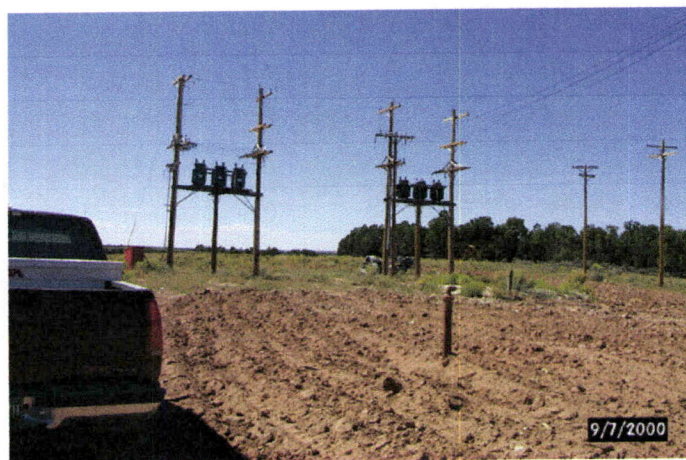
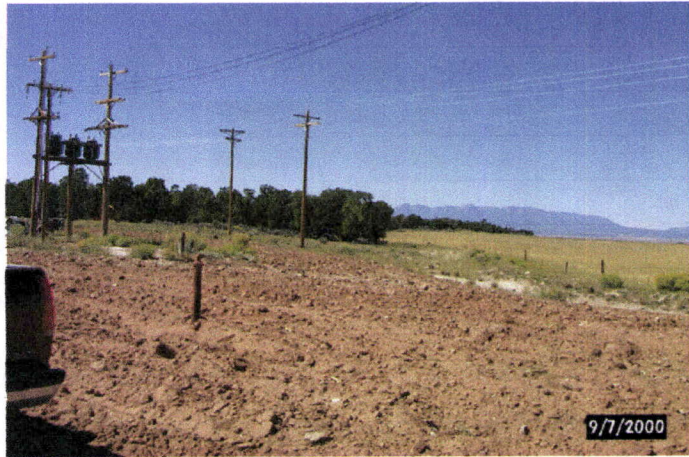
CALLIHAN #1 VENT HOLE

The next feature examined was the Calliham #1 vent hole. The features at this site include power poles with six transformers and a concrete pad. The poles, transformers and the pad are proposed to remain for the use of the landowner. This vent hole was cased. Reclamation included capping the vent hole with a metal plate with a pipe leading down to the lower reaches of the vent hole for access to water by the land owner. Photographs of this site show a regraded area with a pipe coming up out of the ground and power poles and transformers in the background.
